Chenoweth Roofing was at the Coldwater Branch on November 19th and 20th to address our warranty claim. Here's a comparison of the same areas before and after the warranty work. I have forwarded all these pictures to Ken Fickle at the Coldwater city inspector's office. I'm awaiting word on their opinion of the repair job.

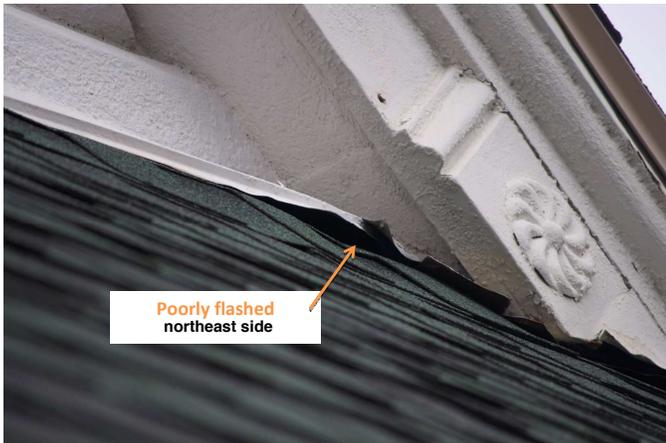
Poorly flashed
northeast side

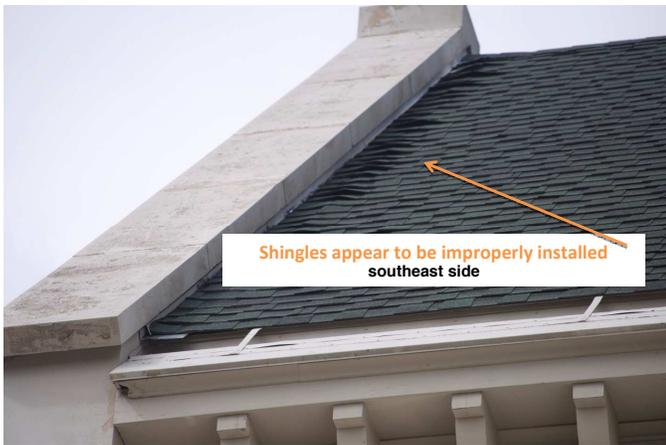
Shingles appear to be improperly installed
southeast side

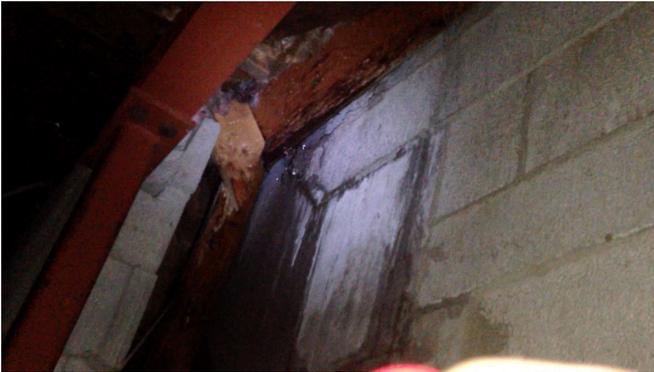
It's clear that some work was done from the ground, but this is the best view we have. Chenoweth worker said flashing had been

improperly installed here.

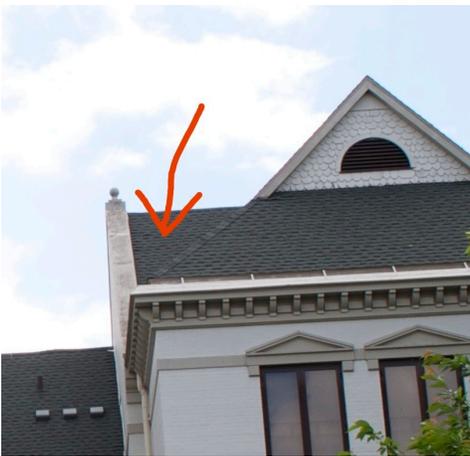
3rd floor leak, west side of 1979 portion of building

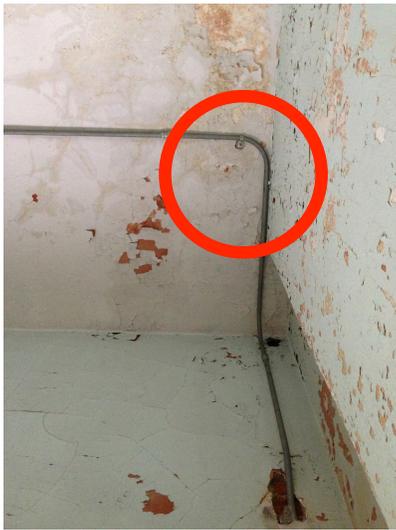
**New active leak (red)
above old main
entrance in local
history room**

Cause of this leak was determined by
Chenoweth workers to be a piece of detached
flashing.
